Quinn Chapel
HPRES 5012 001 Building Diagnostics
Christopher Ciesielski
Spring 2010

Structure

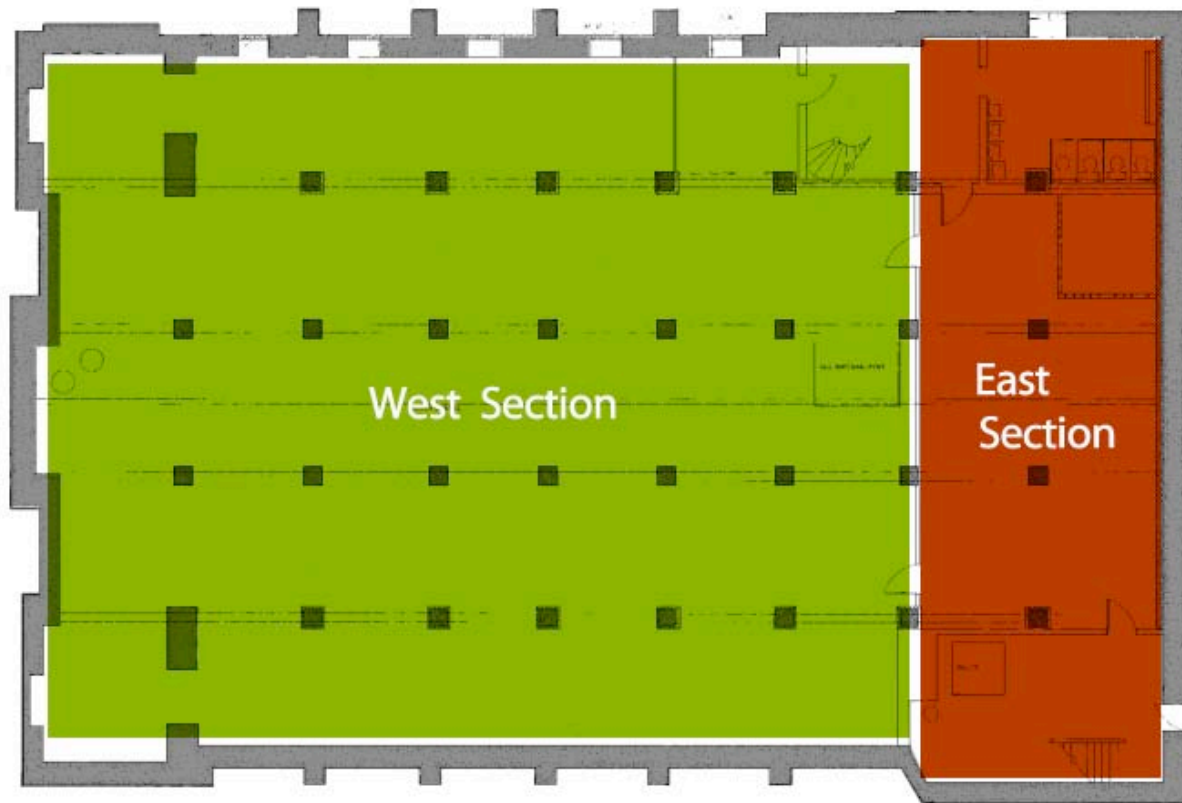
Figure A - Plan showing East and West sections of basement

The basement of Quinn Chapel will be discussed by cutting it into two sections with an east section and a west section. The east section occupies approximately one fourth of the eastern portion of the basement area. The eastern section of the basement has a lower finished floor height finished to approximately six to six and a half feet tall with a concrete slab floor and walls and ceilings have been covered in lathe and plaster and finished with a painted surface. The western section of the basement has a dirt floor and a lower ceiling height of approximately five feet high and the ceilings and walls can best be described as unfinished. The unfinished walls show the exposed limestone foundation and ceilings show the joists and beam structure supporting the first floor above.

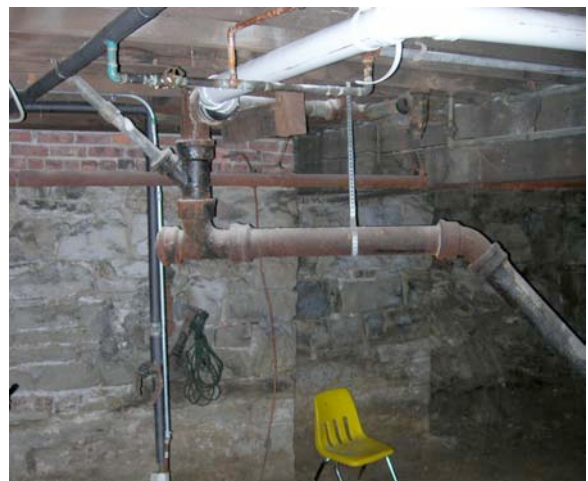
The perimeter basement walls of the entire church are constructed of limestone blocks that have been mortared together. Overall the limestone block foundation exhibits a few areas of surface spalling, missing blocks or visual signs of distress. The visible portion of the mortar holding the blocks together is intact with minimal signs of deterioration. One exception must be made for the eastern foundation wall of the church. This wall was constructed entirely of concrete masonry units and the limestone wall was not visible. The CMU wall is a newer intervention into the structure and from visual inspection is in good condition with no signs of cracking both in the blocks and in the mortar joints. In the western section of the basement, two additional smaller foundation walls that are approximately four foot long by two feet wide are found, built of limestone block. These two walls act as interior foundation walls that support the two towers on the West facade of the church. The walls again exhibit few signs of surface fatigue and no missing block members.

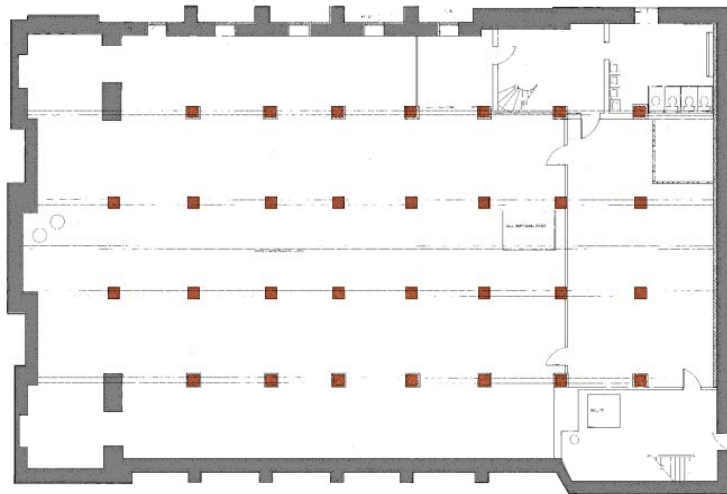
Thirty piers, constructed of common brick are found throughout the basement area. These thirty piers support the upper stories by carrying either a wall or a cast iron column. The brick piers are twenty-four inches square and are set in a grid pattern, eight piers deep by four piers wide. For this example, deep is referred to as from the east to west elevation and wide is referred to as from the north to south elevations. The two smaller limestone foundation walls, mentioned above, take the place of two piers on the northwest and

southwest corners of the basement. The brick piers are set on concrete footings, and rise up to terminate at the base of the first floor framing. Two brick piers located in the western portion of the basement have been altered. The top caps of the columns have been rebuilt with a flared top entirely in masonry and the columns are higher than the rest found in the adjacent area. The two rebuilt piers extend through the flooring. All the brick piers found throughout the basement exhibit no signs of cracking or missing members.

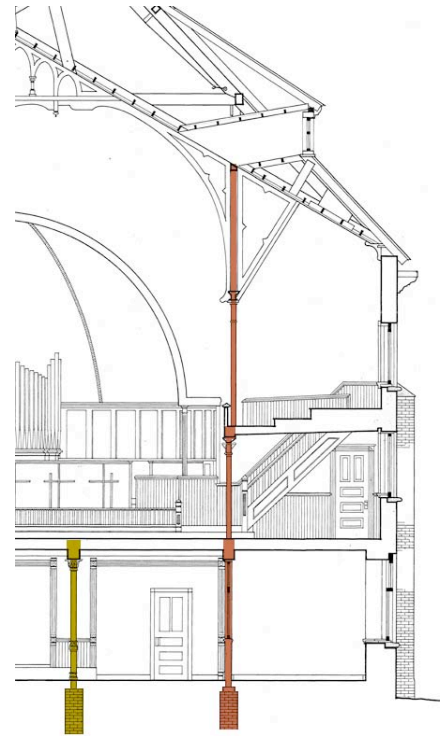
At the top of the brick piers two types of systems were found. On the north and south rows of piers a limestone block was placed onto which the cast iron plate of the column was placed. The center two rows of piers simply terminated with common brick onto which the iron plate for the column was placed. Initial research shows that the outer two rows of piers carry the weight of the first floor, sanctuary space floor, balcony area and the scissor truss system from the roof above. The inner two rows of piers carry only the weight of first floor and sanctuary space above. Because of the difference in loading on the inner and outer rows of columns one possible explanation is that the limestone block helps distribute the weight as the load is transferred down through the brick pier.

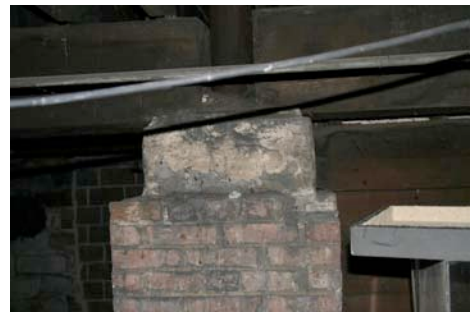
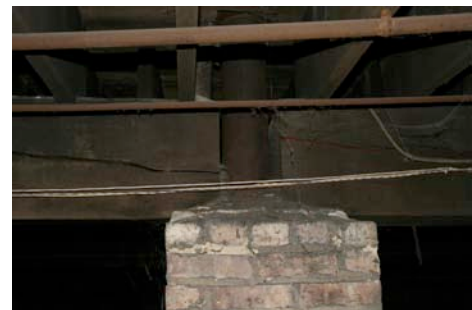
Atop each of the brick piers a cast iron column is placed. These cast iron columns consist of the shaft of the column, which continues through the floor to the upper stories, and a base plate that sits atop either the brick pier or limestone block. The cast iron columns and base plates exhibit few signs of surface corrosion. No holes or cracks were observed in the columns or base plates throughout the basement area.

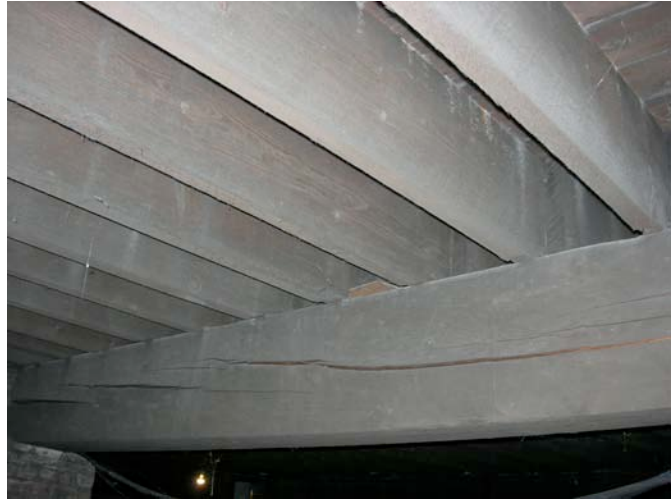
In addition to the brick piers supporting the cast iron columns, they also support timber beams that create the flooring structure for the first floor. Four rows of beams measuring thirteen and three quarter inches tall by nine and a half inches wide span between the brick piers. These beams span east to west in the church and provide the main structural support for the floor joists which span between the beams. The beams exhibit a noticeable downward deflection at mid span and surface checking was also visible in many of the timbers throughout the basement. The beams are in good overall condition and the deflection was consistent from one beam to another. The checking was found mainly in the center portions of the beams, which is likely due to the beam drying out over time. No noticeable vertical cracking running across the grain was seen where the beams met the brick piers or mid span and wood rot was also not seen throughout the basement.

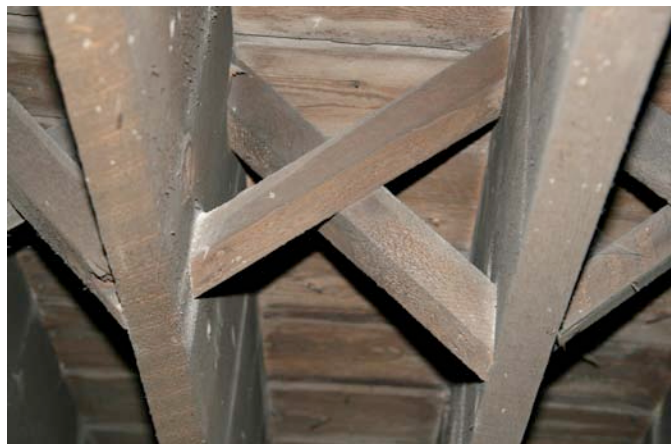
Atop the wood beams the floor joists of the first floor are placed. Where the large beams run east to west in the church, the two-inch by twelve-inch floor joists, spaced at twelve inches on center, span north to south. The floor joists measure two inches wide by twelve inches tall. The floor joists are crossed braced from one joist to another dimensional lumber. The floor joists do not exhibit any deflection as was found in the large beams. Rot was not seen in any of the floor joists or in any of the cross bracing. Where the floor joists tied into the outside walls, visible portions of the timbers were free from rot and decay and it is also worth noting that the floor joists tied into the outside wall through common brick and not directly into the limestone foundation. In the unfinished western portion of the basement the limestone foundation continued up to approximately five feet above the dirt floor. Above the five-foot mark the perimeter foundation transitioned to common brick and that is what the floor joists tied into.

Atop the floor joists wood planks of the subfloor for the first floor are visible. The wood plank subfloor was placed perpendicular to the floor joists and was butt jointed with no space being left between boards. Water staining could be seen on the underside of the subfloor especially in the southwest corner of the basement where there is known substantial water infiltration from a leaking roof. The subfloor exhibited several signs of water staining although no rot or decay was found.

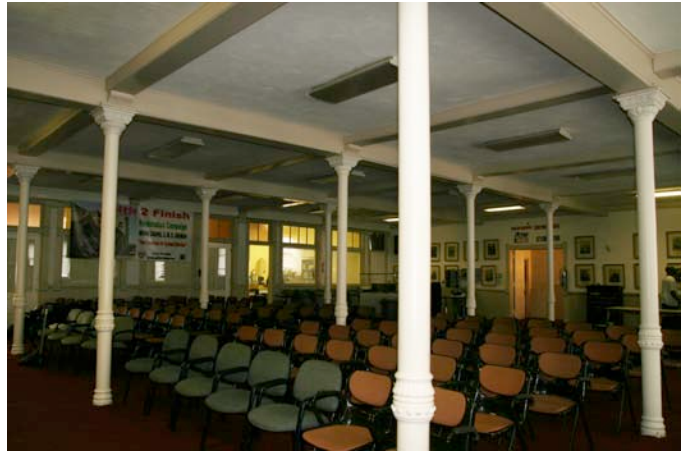
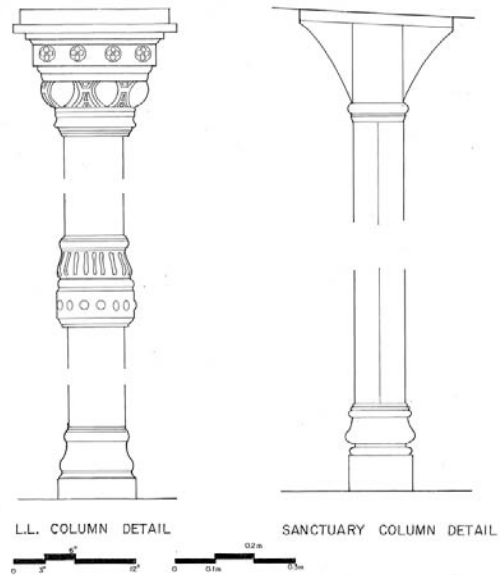
The first floor space of the church is composed of many of the same structural elements that were found in the basement aside from one major element. Instead of the brick piers supporting the upper floors, now the cast iron columns are visible throughout the structure. In the basement the base plate and base of the column shaft was seen atop the brick pier. Here in the first floor space, the cast iron columns continue through the floor upward to the ceiling to support the flooring structure of the second story sanctuary space. The cast iron columns have a painted surface and decorative cast iron capitals have been fixed to the tops of the columns where they meet the ceiling surfaces. Not all thirty columns are visible in the first floor space as some are buried inside interior walls.

Examining the visible fourteen columns all exhibited no signs of surface corrosion although some decorative capitals were missing or had signs of separating where the two cast iron capital pieces met.

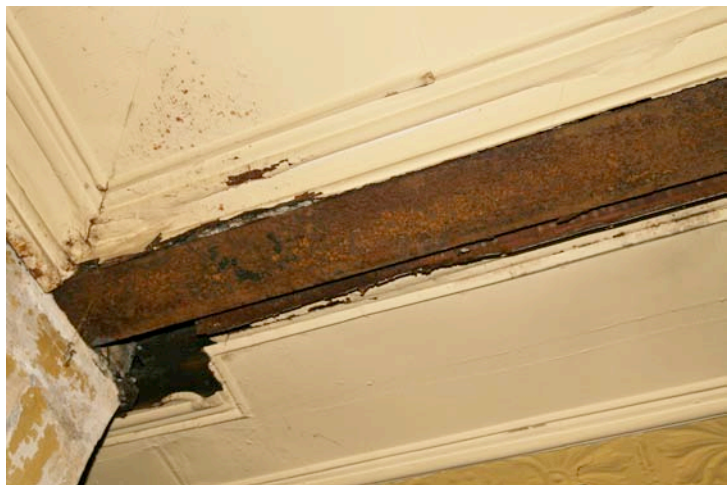
space and are finished with a painted surface. All columns were in good overall condition with no signs of surface corrosion or cracking. One portion of the sanctuary space, the southwest corner of the church, suffered extensive water damage from a leaking roof. In this area the plaster was partially missing and a

metal I-beam was present. This metal I-beam was found supporting the northern edge of the southern balcony. Where the large timbers spanned between the cast iron columns on the first floor below, here the metal I-beam spans between the cast iron columns. The metal I-beam did have surface corrosion in the water-infiltrated area although enough of the beam was not present to make a good visual examination. The remaining structural elements of the sanctuary space were covered with lathe and plaster finish and a visual inspection could not be made of the floor joists or remaining metal I-beams. Again all the interior walls were covered with a plaster finish and only minor cracking was seen on the exterior load bearing walls.

1. In the sanctuary space, further testing and examination should be made to determine if the metal I-beam was structurally compromised by corrosion caused by the water infiltration.

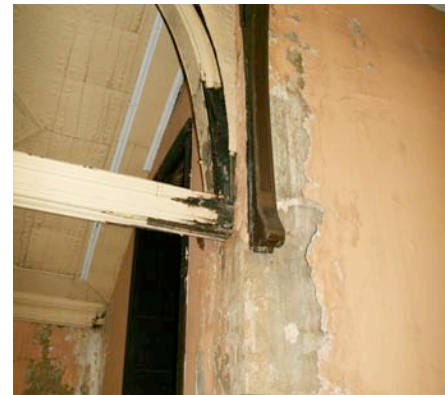
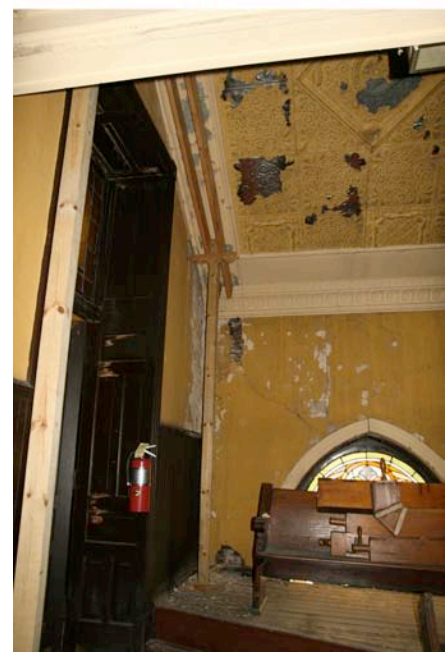
In the balcony area all eight visible cast iron columns were examined and found to be in good condition. All the columns have a painted surfaces and no surface corrosion or cracking was seen. The wooden roof truss system was examined and found to be in good condition. There are metal angle brackets that hold the center truss to the roof trusses and this appears to be a recent intervention. The metal brackets are not painted and through bolted. Several areas of the truss system had peeling paint especially in the water-damaged areas. In the southwest corner of the balcony where the east-west structural beam ties into the southwest tower extensive wood rot was found. This area correlates to the rusted metal I-beam found directly underneath in the sanctuary space. In addition to the rotted beam, temporary supports were constructed using two by four inch dimensional lumber. This bracing ran along the balcony roofline and ran down to the floor at the southwest corner of the balcony and along the southwest wall of the tower that sustained heavy water damage.

2. In the balcony space, further analysis should be conducted to determine the extent of wood rot of the structural member in the southwest corner. Surface rot was visible to the finished carpentry and signs of heavy water infiltration were found in this area. The wooden beam should be examined to confirm that it is not compromised.

3. In the southwest corner of the balcony area further examination is recommended to see what structural issues will need to be addressed to remove the temporary bracing.

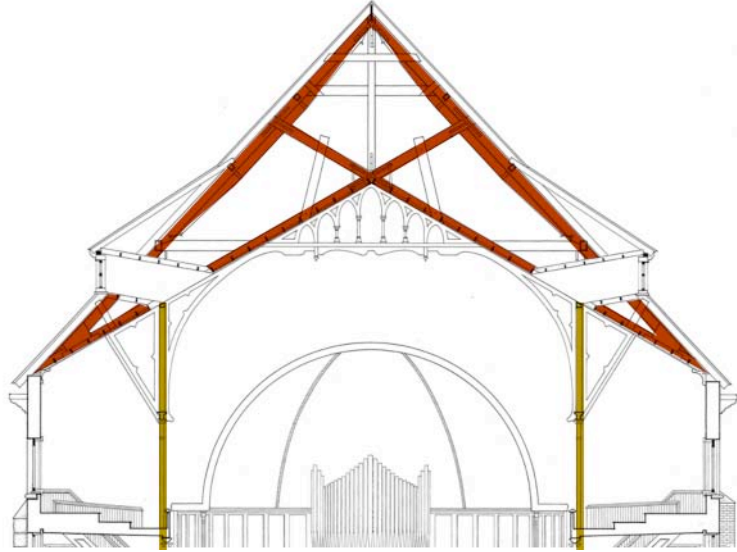
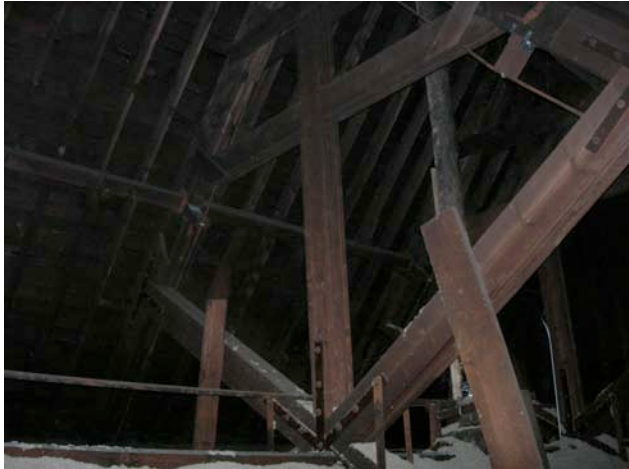
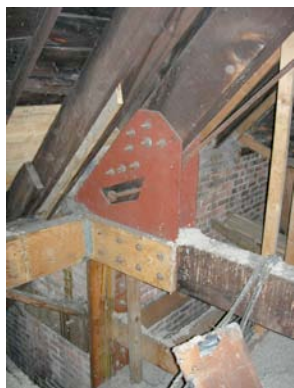
A scissor truss system composed of wood beams and sandwiched two by twelve lumber supports the roof. The scissor truss system found in Quinn Chapel is composed of four structural members. Two top beams frame out the roofline of the church while two beams cross diagonally underneath forming an “X” shape.

underneath forming an “X” shape. This “X” transfers the downward thrust created by the weight of the roof to the outside walls. The effect achieved by using a scissor truss system is that interior spaces can now be vaulted achieving greater height and volume in the sanctuary space. The wooden members are used in conjunction with metal rods and structural steel plates to create the truss system. The scissor truss

system is buttressed from outward thrust on north and south sides of the church by brick buttresses that are visible on the outside of the church walls reaching upward to the roofline. At the roofline the buttresses meet the trusses where they tie into the outside walls. On the inside of the church two outer rows of cast iron columns that continue up through balcony area provide vertical support to

the truss system allowing load to be transferred back down to the brick piers in the basement. The scissor truss system appeared in good overall condition with no deflection in the span and no checking as had been found in the floor timbers on the lower stories. One major intervention was seen in the southwest corner of the attic area. A series of wood joists and timbers had been cut out and laminated beams had been inserted. At the junction of where the joists met

the large timbers a large piece of structural steel was inserted to tie the old portions to the new. Also a large area of roof decking boards had been replaced in the vicinity of the repairs. This area correlates directly to the rotten timbers and corroded metal beam-beam found directly below on the lower stories. On the day of examination the repaired area appeared dry and this was confirmed by examining the same area on the lower floors. Also it is worth noting that prior to the examination several days of rainy weather had occurred and the repaired area showed no signs of moisture infiltration.

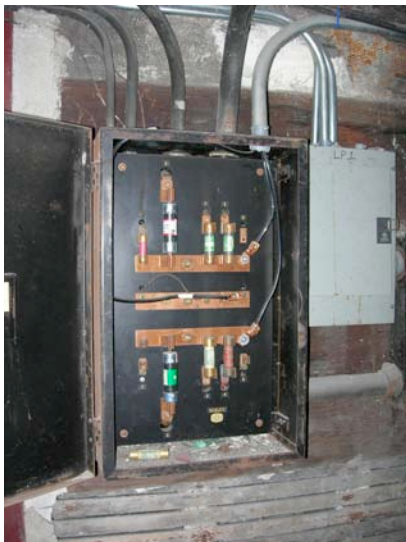
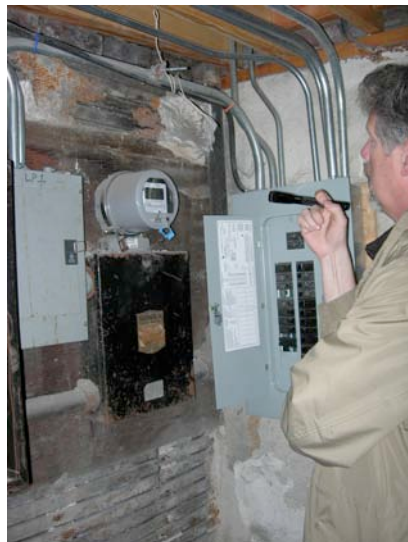
The electric panels at the southeast corner of the basement are a mix of breaker panels and fuse boxes that feed to various locations throughout the church. The breaker panels appeared to be newer

although no date was found on them. The fuse panel adjacent to the breakers contained eight fuses. Again there was no date or labeling as to what this panel fed. Throughout the remainder of the basement several other subpanels were found and were a mix of fuse panels and

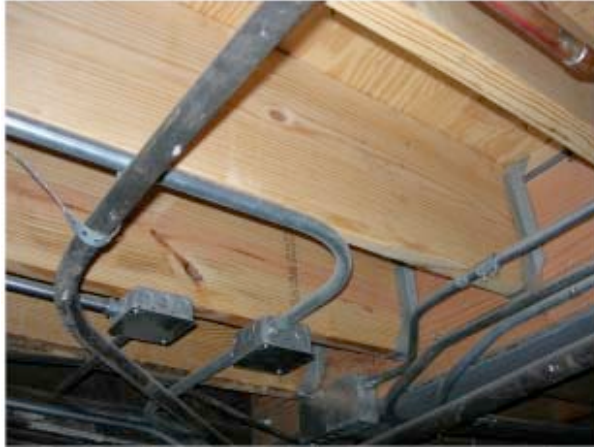
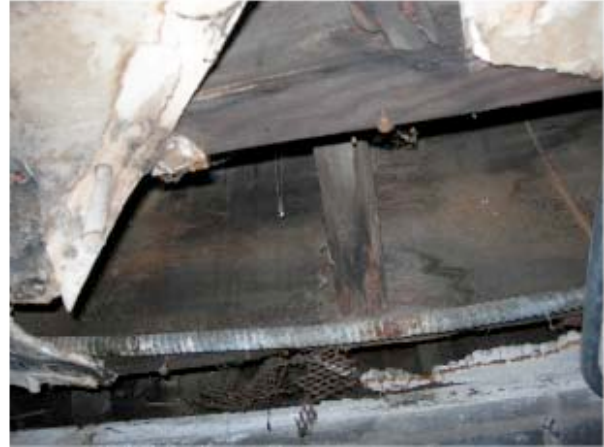
breakers. There were several different generation of wiring found in the basement area. Remnants of knob and tube wiring were found. All since removed, the ceramic conductors were the only pieces left that led to this discovery. Secondly rigid black conduit was found containing cloth-wrapped wiring. This was

determined when a junction box was discovered without a cover plate. The cloth wiring wrapped with electrical tape lie inside and from the box led a semi-rigid armored cable. The semi-rigid cabling fed through the floor to the first floor of the church. And finally, rigid galvanized conduit was found from the recent renovations. This conduit was in good condition and no open junction boxes were found using this system.

4. It is recommended that a general code review be performed of the entire electrical system of the church. Junction boxes missing covers, electrical junctions outside junction boxes and Romex wiring were found in our inspection.

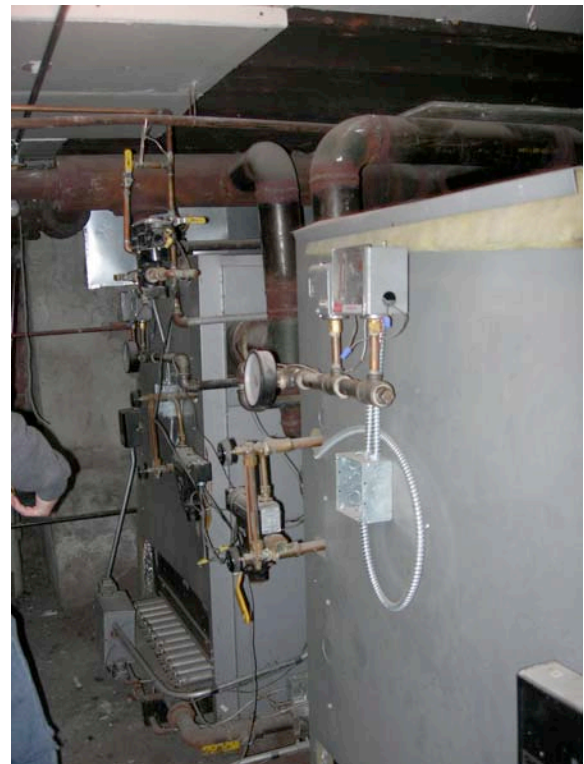
The heating system of Quinn Chapel is a natural gas fired steam radiator system composed of both single and double pipe radiators. In the east corner of the basement, adjacent to the men's restroom a large oil tank is present. The tank has two pipes extending from the top of the tank, both of which are cut off and capped. Prior to the natural gas fired burner, oil was used to heat the chapel, although the date of transition is unknown. The natural gas supply enters the basement at the northeast corner of the building adjacent to the men's restrooms. A gas pipe then runs south across the basement to the boiler room

located at the southeastern corner. Inside the boiler room, two large boilers are found and appear to be in working order. Again no date was found on the boilers but at the time of examination both were working

and a flame was present inside each of the boiler tubes. The steam lines that fed from the boiler showed signs of surface corrosion. The steam lines that fed from the boiler divided into a large array of smaller metal lines that fed throughout the building. The supply lines were in good condition and of the ones examined terminating at the radiators none were to be leaking or contain surface corrosion.

5. The steam lines that fed from the boiler showed signs of surface corrosion. Further testing by a licensed professional would be needed to determine if this surface corrosion is of any concern.

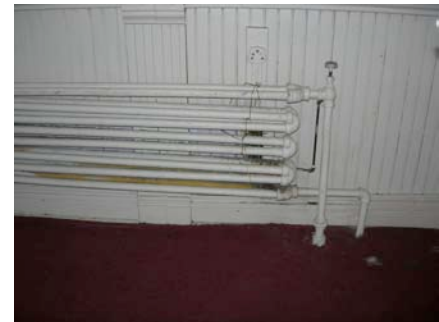
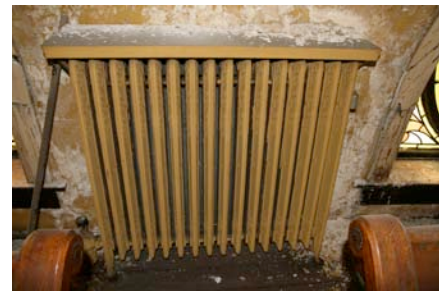
The radiators found throughout the church were a mix of single and double pipe systems. On the first floor double pipe radiators were found on the south walls of the assembly space but adjacent them on the north wall, single pipe radiators were found. The radiators found on the north wall were much more decorative, having patterns cast into the fins. These decorative single pipe radiators were typical of what was seen throughout the rest of the church. In the sanctuary space the radiators found in the balconies and main nave matched those found in the first floor assembly space identically. All the radiators found throughout the church were in good condition, showing no surface corrosion and of those examined, none appeared to be leaking.
