Quinn Chapel
HPRES 5012 001 Building Diagnostics
Christopher Ciesielski
Spring 2010

Structure

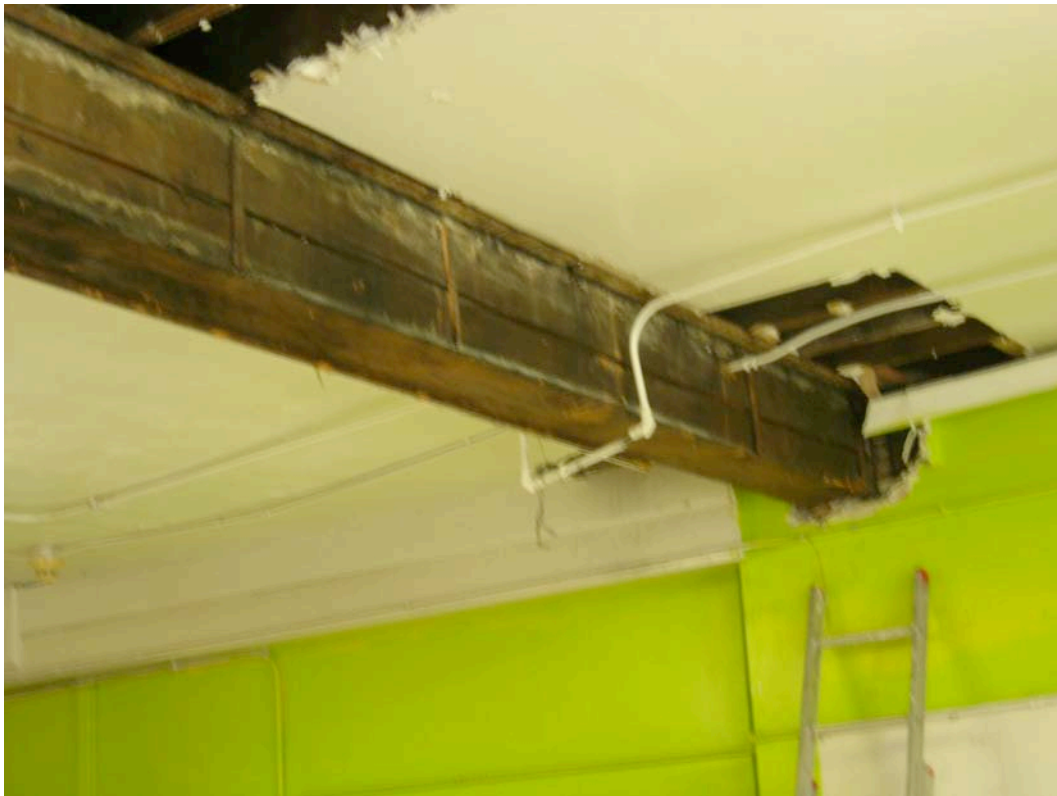
Examining the visible fourteen columns all exhibited no signs of surface corrosion although some decorative capitals were missing or had signs of separating where the two cast iron capital pieces met.

Much of the structure that was visible in the basement was obscured by finished walls and ceilings on the first floor level. One portion of the first floor, the eastern portion, was undergoing renovation and the ceiling structure was visible. Here the same timber beam was seen running east to west spanning between the cast iron columns. The beam exhibited the same features as were seen in the basement. The beam had downward deflection that was visibly noticeable mid span and surface checking was seen toward the center surfaces of the beam. Atop the large beam two by twelve inch floor joists at twelve inches on center were placed identical to what was seen in the basement. The beam and floor joists that were visible exhibited no rot or vertical cracking and were in good overall condition. The exterior walls of the church were covered in a plaster finish and the load bearing masonry was not visible on the interior.

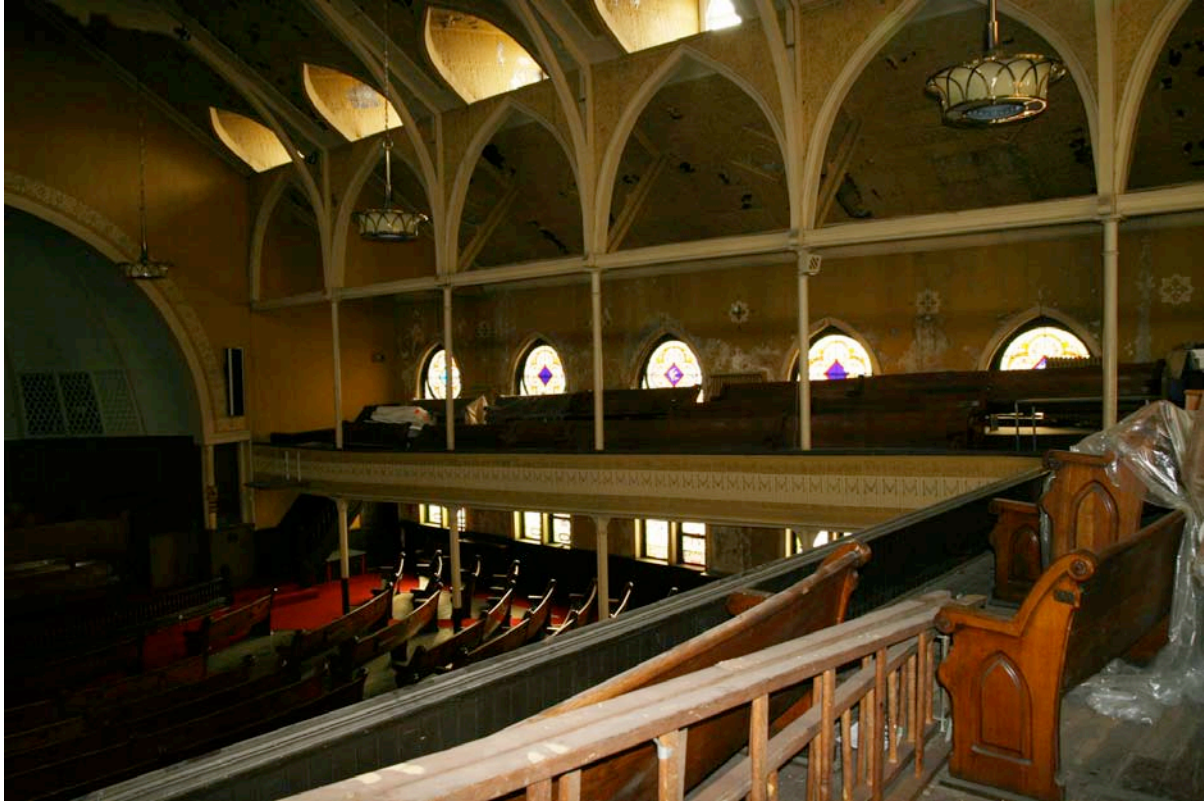
space and are finished with a painted surface. All columns were in good overall condition with no signs of surface corrosion or cracking. One portion of the sanctuary space, the southwest corner of the church, suffered extensive water damage from a leaking roof. In this area the plaster was partially missing and a

metal I-beam was present. This metal I-beam was found supporting the northern edge of the southern balcony. Where the large timbers spanned between the cast iron columns on the first floor below, here the metal I-beam spans between the cast iron columns. The metal I-beam did have surface corrosion in the water-infiltrated area although enough of the beam was not present to make a good visual examination. The remaining structural elements of the sanctuary space were covered with lathe and plaster finish and a visual inspection could not be made of the floor joists or remaining metal I-beams. Again all the interior walls were covered with a plaster finish and only minor cracking was seen on the exterior load bearing walls.
